Evaluation of the Climate in a New Shared Storage Facility Using Passive Climate Control.

Michael Højlund Rasmussen, M.Sc.

Vejle Cultural Heritage Centre

Museum Microclimates Copenhagen November 2007

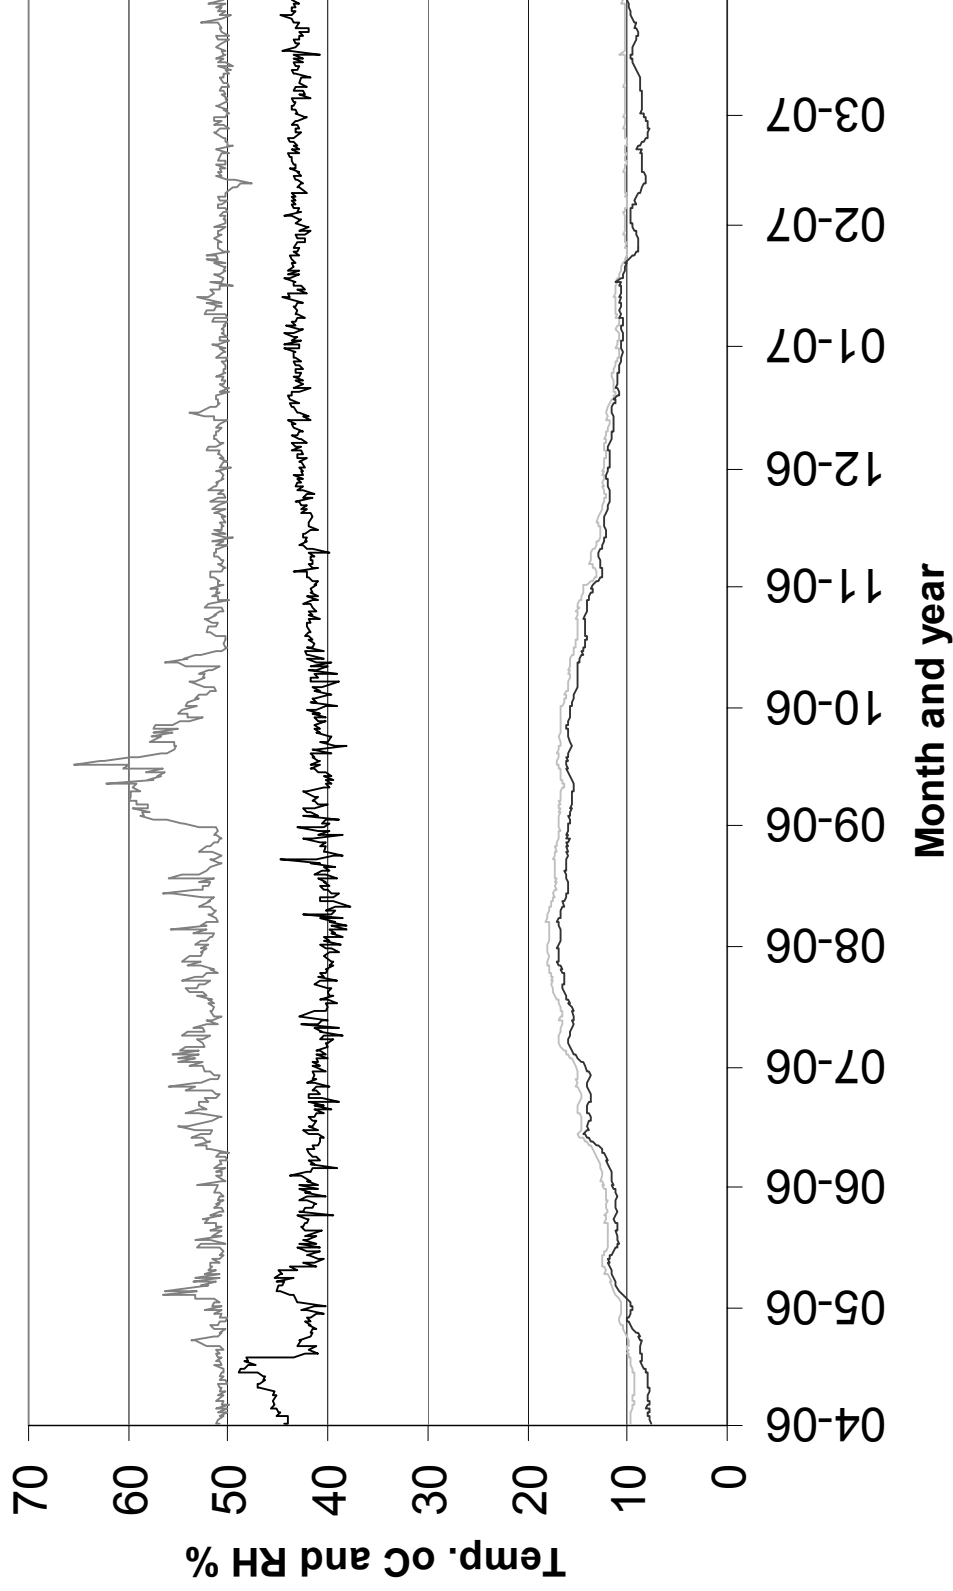
Halls C (grey trace) & B (black trace)

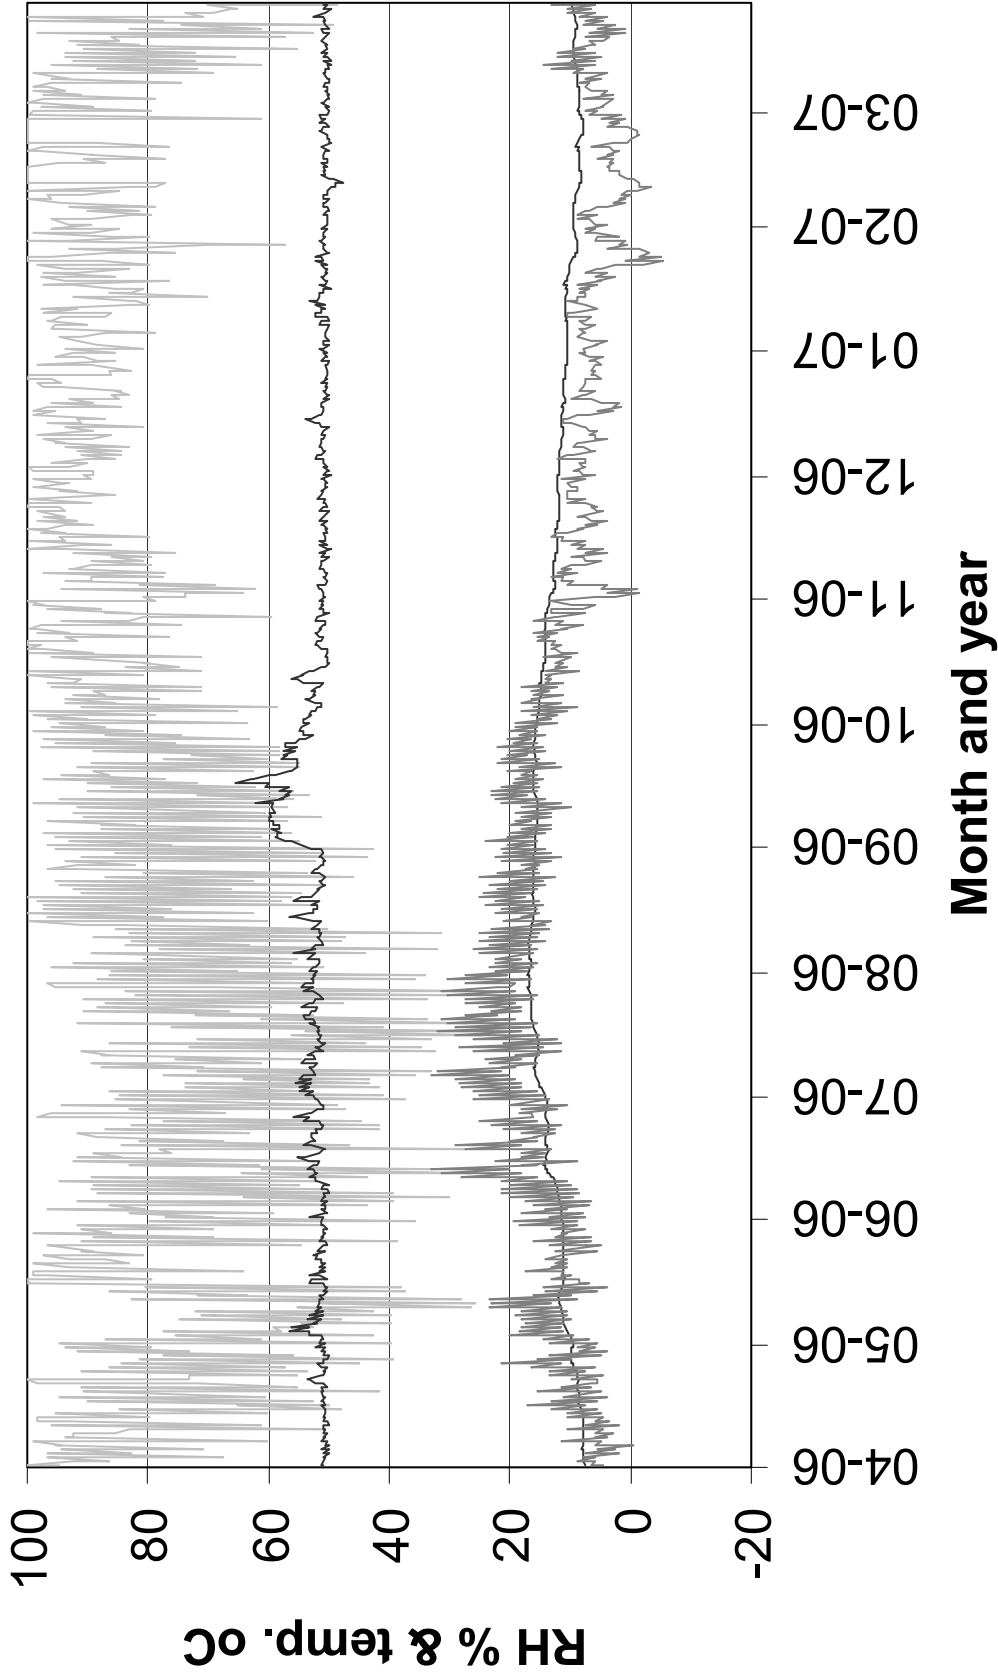
Hall C (black) compared to outside climate (grey)

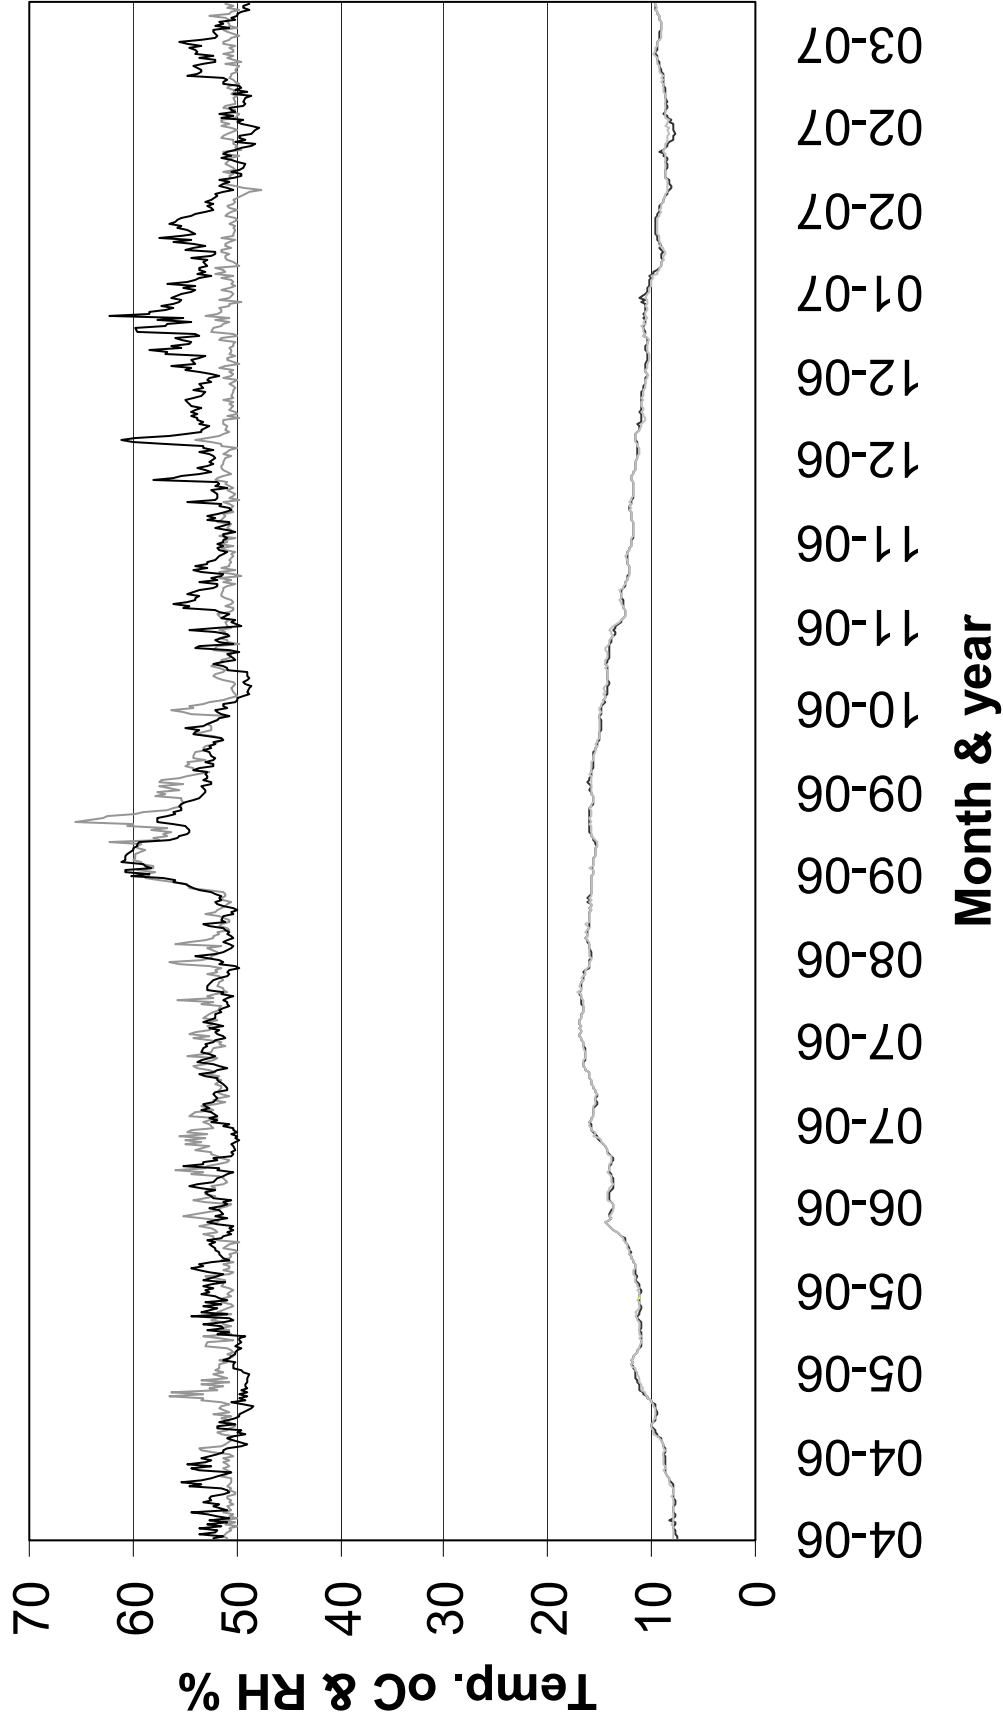
Comparison of Halls A (black trace) and C (grey) – difference suggests more traffic i hall A

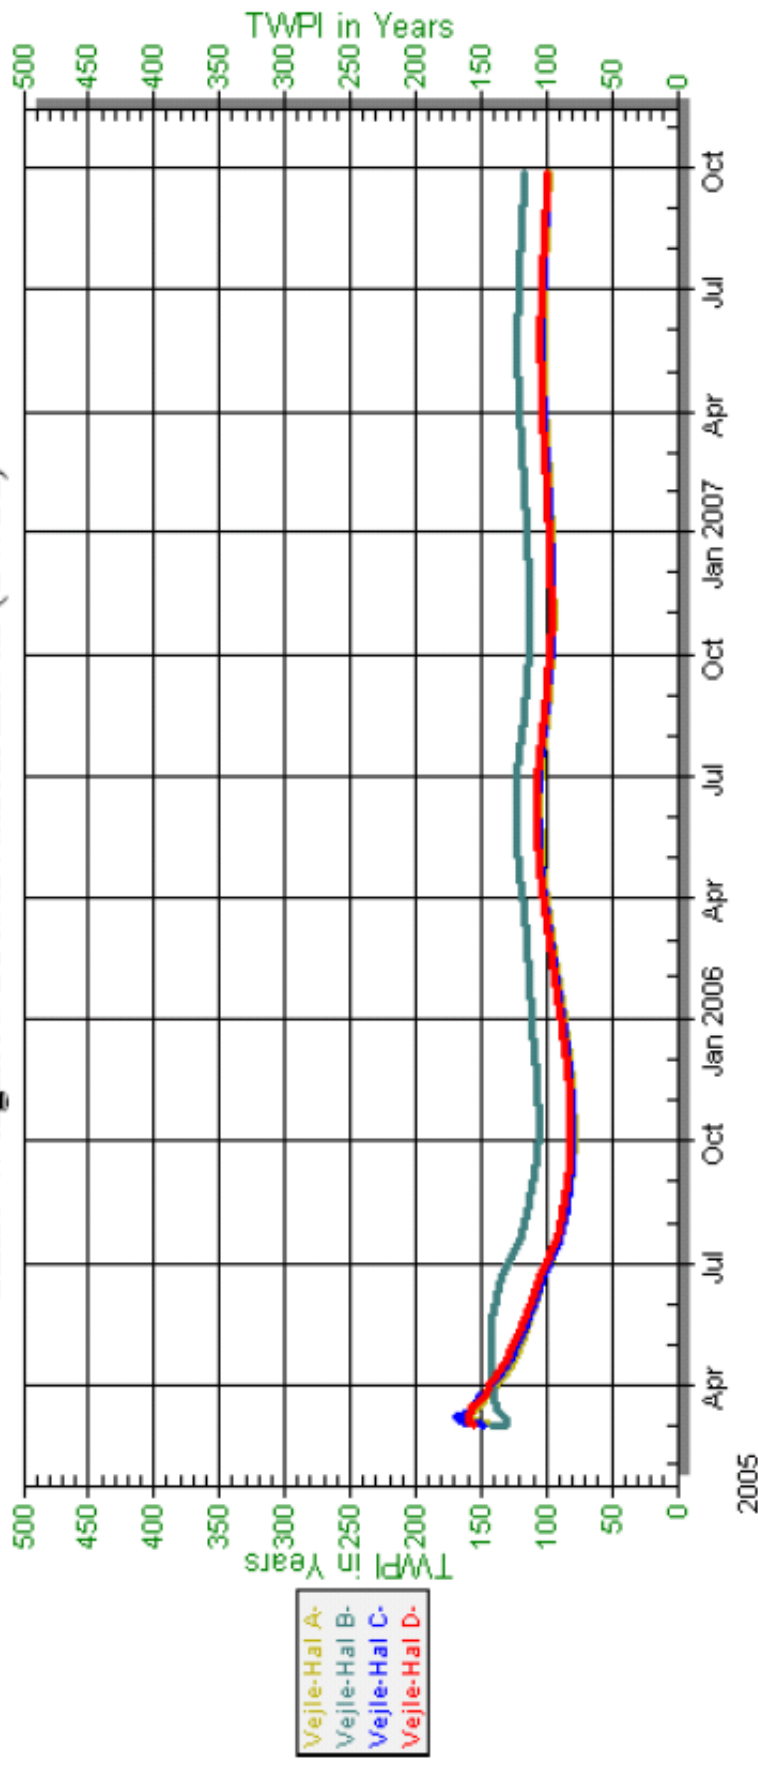
Time-Weighted Preservation Index (TWPI)

- Low average temperature is preferable
- TWPI is an index indicating how long time a material will remain chemically stable under certain climatic conditions (Climate Notebook software from Image Permanence Inst., Rochester, USA)
- The Time Weighted Preservation Index (TWPI) is high - about 100 for halls B,C & D and 117 for hall A
