CLIMATE CONTROL IN DANISH CHURCHES

POUL KLENZ LARSEN

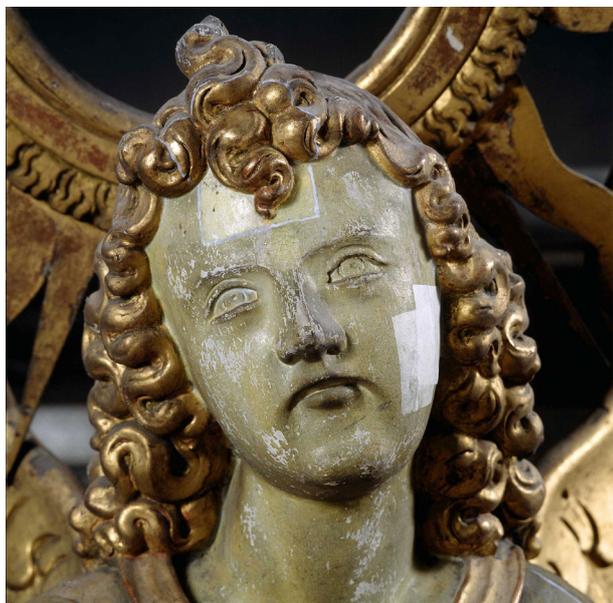
Figure 2. Detail of the altarpiece in Sct. Olai Church in Helsingør. The paint has cracked and partly delaminated due to variations in relative humidity caused by constant heating. Photo by Roberto Fortuna, the National Museum of Denmark.

The Gothic cathedral of Sct. Olai in Helsingør is a large brick masonry structure with a magnificent baroque altarpiece. The last restoration was undertaken in 1967, but 30 year later the gilding and paint was cracking and peeling. It was essential to improve the climatic conditions in the church, which was at that time permanently heated by a central heating system with large cast iron radiators. The temperature was around 20°C all year round, and the RH drifted from 80% in summer to 20% in winter. This variation is a natural consequence of the annual fluctuation in the water vapour content of the outside air. If the ventilation rate is large, and the internal moisture supply is small, the indoor water vapour concentration (the absolute humidity) will be the same as outside. To reduce the drying in winter, the average temperature should not be more than 15°C. But this was not acceptable, partly because of cold draughts below the large windows and in the central nave. Floor heating was established to maintain thermal comfort at a reduced temperature. The large windows had double glazing installed to prevent convective air movements and to reduce the natural ventilation. This intervention

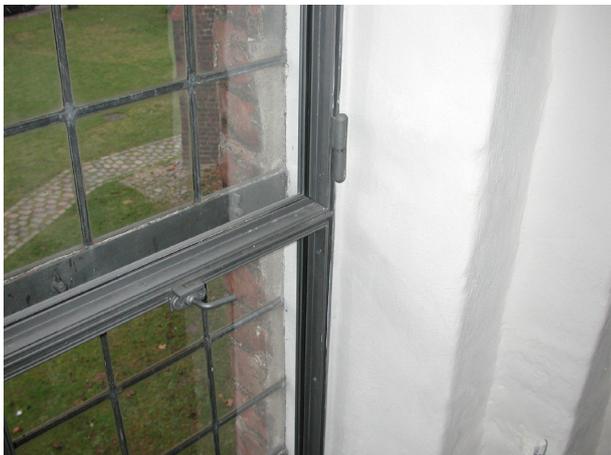
Figure 5. Detail of the windows in Sct. Olai church. The framing for the double glazing was custom designed to fit the original leaded windows. Photo by Poul Klens Larsen

is usually not allowed for architectural reason, so a custom designed frame was fitted inside the original windows. These changes have improved the climate in the church, so the annual average variation in RH is limited to 30%-60% with little diurnal fluctuation. An unexpected complication occurred during construction work, when numerous crypts with wooden coffins were found below the old floor. The mummified bodies wearing fine clothes were in quite good condition, so their microclimate had been congenial for centuries. We were worried about how the new floor heating would influence

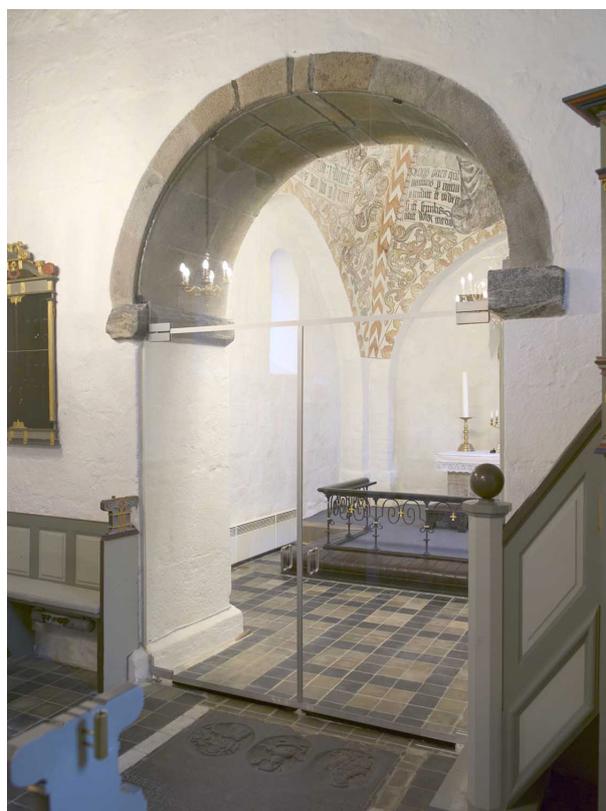
Figure 8. View through the glass door in the chancel arch in Dybe church. The lime painting in the vault is visible in the chancel. The heating elements on the wall below the vault are controlled by a hygrostat to keep the RH at 70-80% all year. Photo by Roberto Fortuna, the National Museum of Denmark.

It was decided to restore the paintings and prevent further decay by climate control. A glass door was installed to separate the chancel from the nave. The door would remain closed at all times, except for the services, when it was opened for one hour. The climate in the chancel was regulated with the help of a hygostat, turning on a little heat to keep the RH in the range 70% - 80%. One should be aware that the RH measured inside the chancel is not the same as the climate at the surface of the vault. In winter the RH is higher at the surface because the temperature is slightly lower, but in summer the RH is a little lower because the attic is heated by sun radiation. But the RH is still much more stable than in the nave, which is heated at irregular intervals over the winter. This simple installation has now worked for 3 years and no damage has been observed.

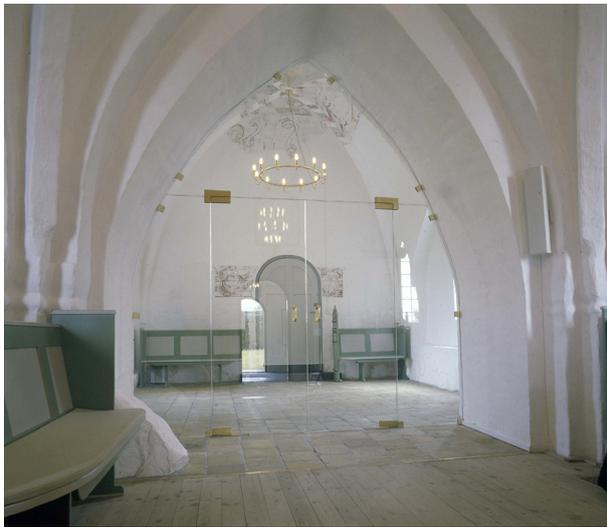
Figure 9. View through the transparent wall into the chapel in Ølsemagle church. Fragments of the wall paintings are visible on the wall and in the vault. The chancel is unheated, so a cool and humid climate is maintained all year, except for special occasions when the glass door is opened. Photo by Roberto Fortuna, the National Museum of Denmark.

A similar solution was adapted for Ølsemagle church in Zealand. The congregation wanted to use a former chapel on the north side of the nave for extra seats on special occasions. The extension had been used as a tool shed for many years, unheated, with a stable but humid indoor climate all year. The walls and the vault had well preserved fragments of wall paintings, which would possibly deteriorate in a warmer and dryer indoor environment. There are many reports about lime paintings suddenly flaking due to a change in the heating practice. In some cases the installation of new heating systems has even led to the rediscovery of wall paintings which had been covered for centuries by thick layers of lime wash. The paintings were revealed because the lime wash lost adhesion when the structure dried

out due to the improvement in heating capacity. The conservator demanded as little change in the climate as possible, so a transparent glass wall was installed in the arch, with a door to open for the Christmas ceremony. On ordinary days the chapel is not accessible. No heating was installed, but the heat transmission from the nave keeps a slightly higher temperature than before, with an average RH at 80%.
